**Performance Monitoring of State Highway 289 in Grayson County, Texas**

Stacy L. Hilbrich, P.E.  
President  
H&L Engineering and Testing, Inc.  
P.O. Box 12338  
College Station, TX 77842  
Phone: (979) 774-6025  
Fax: (979) 774-6009  
stacy@handengineering.com

## **INTRODUCTION**

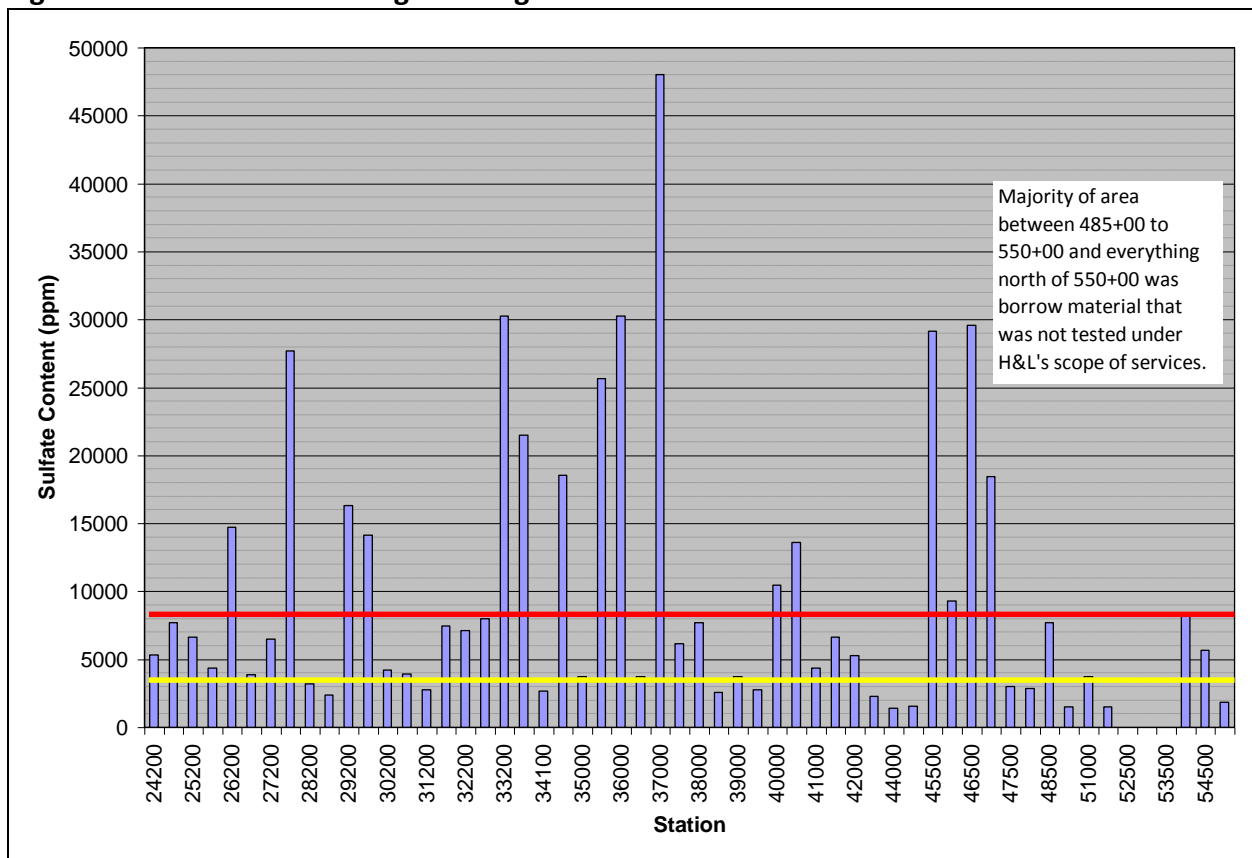
Testing in the field was conducted in accordance with TxDOT test method TEX-146-E, in which the conductivity of the soils is measured in an effort to identify the extent of the sulfate concentration and to determine where materials were to be sampled for further laboratory testing. The actual sulfate concentrations of the sampled materials were then determined in the laboratory in accordance with TxDOT test method TEX-145-E. Based on the results of these two tests, materials collected from stations 277+00, 307+00, 370+00, and 465+00 were selected for inclusion in the laboratory mix design to be discussed later. Results of the sulfate testing along the length of the project north of US 82 are shown in Figure 2.

**Figure 2. Sulfate Results Along the Length of SH 289 North of US 82**

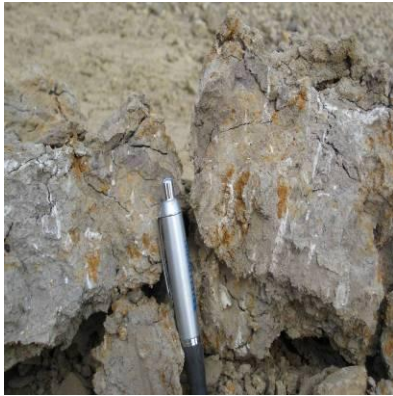
**3a. Station 277+00**

High concentrations of sulfate deposits were observed all along the project during the field investigation. These pockets of sulfates included gypsum crystals in a broad range of concentrations and sizes. Some examples of the variety of sulfate concentrations and crystal sizes observed on the project are shown in Figure 3.

**Figure 3. Variety of Sulfate Concentrations and Crystal Sizes Observed at Various Locations**

The drastic difference in both swell and strength results obtained in the laboratory at stations 277+00 and 465+00 was surprising. In the visits to the project to evaluate the performance of the lime stabilized subgrade, several observations were made that could potentially explain this difference in performance. The most notable difference in material observed in the field was the size of the gypsum crystals. Refer back to Figure 3 for an example of this.

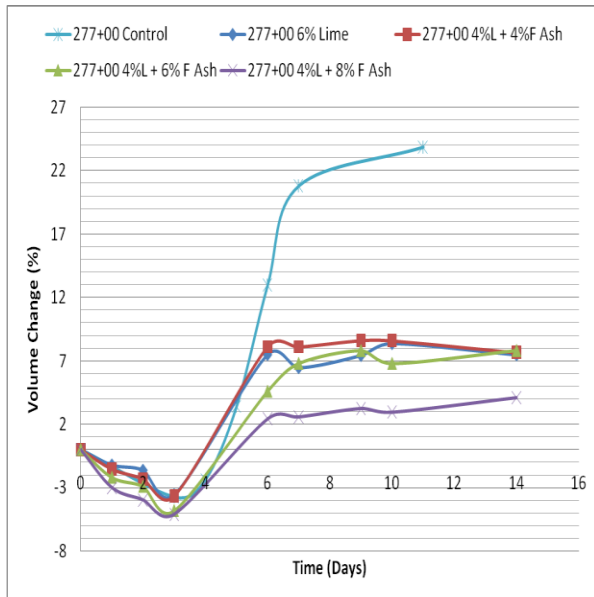
**4a. Station 277+00 Swell Results**

application in the lab and allowed to mellow for 3 days prior to molding the samples. The stabilizer contents that were evaluated in the mix design were as follows: 6 percent lime, 4 percent lime + 4 percent class F fly ash, 4 percent lime + 6 percent class F fly ash, and 4 percent lime + 8 percent class F fly ash. A control sample with no additive was also fabricated for comparison. Results of the volumetric swell tests are shown in Figure 4.

**Figure 4. Volumetric Swell Results**

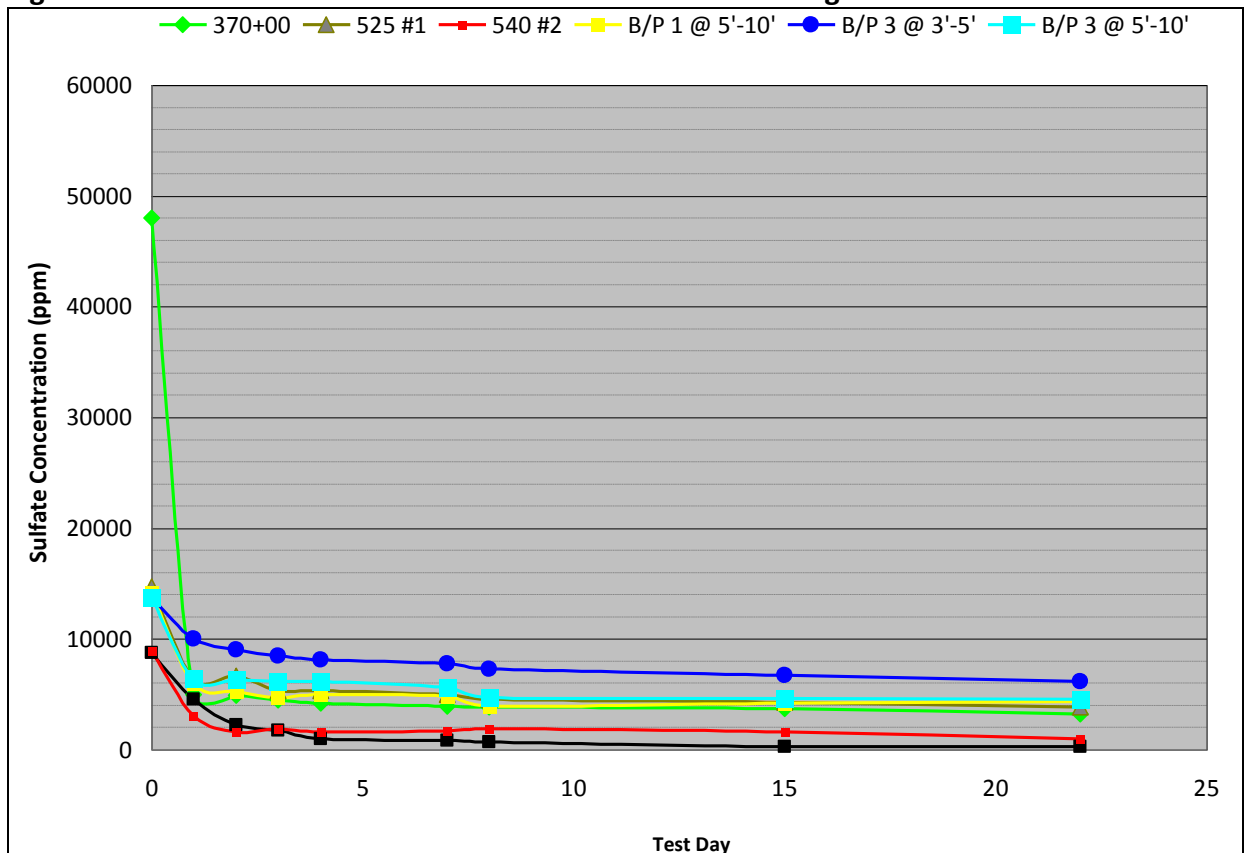
These results were encouraging in that the initial lime treatment and mellowing reduced the sulfate content in the soils to the levels that TxDOT considers low risk. This seemed to collaborate with the other findings; namely that lime appears to have been effective in the field (no apparent swells) and in the lab (strength gain with no major swells). Additionally, H&L conducted sulfate testing with time to verify the reduction in sulfate concentrations. For this testing, 3 percent lime was added to the soil samples at optimum plus 2 percent moisture with an additional 1 percent moisture added daily until no further drop in sulfates was realized. Then another 3 percent lime was added along with additional moisture after 7 days of testing, and sulfates were monitored for another 15 days. These results are shown in Figure 5.

**Figure 5. Sulfate Concentrations with Extended Lab Mellowing**

If this section continues to perform well with time it could indicate that the testing sequence undertaken in this project would be a better test of lime's ability to treat soils with high sulfate content. If the soil does well in strength gain, volumetric swell and also shows a large drop in available sulfates then it should be a good candidate for lime stabilization.

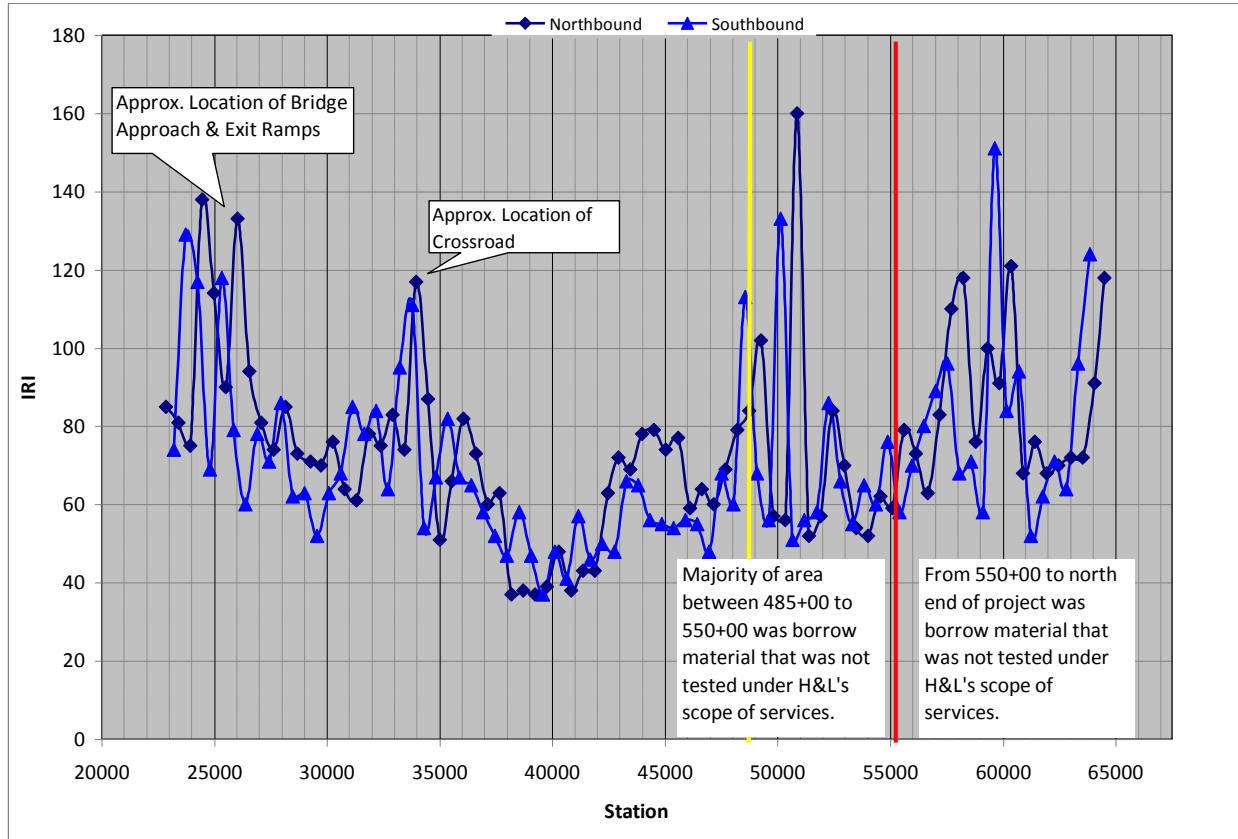
Quality for Pavement Surfaces and utilized the profile data to evaluate the possibility of the development of sulfate induced heave. Results from the profiling are shown in Figure 6.

**Figure 6. Profile Data for SH 289 North of US 82**

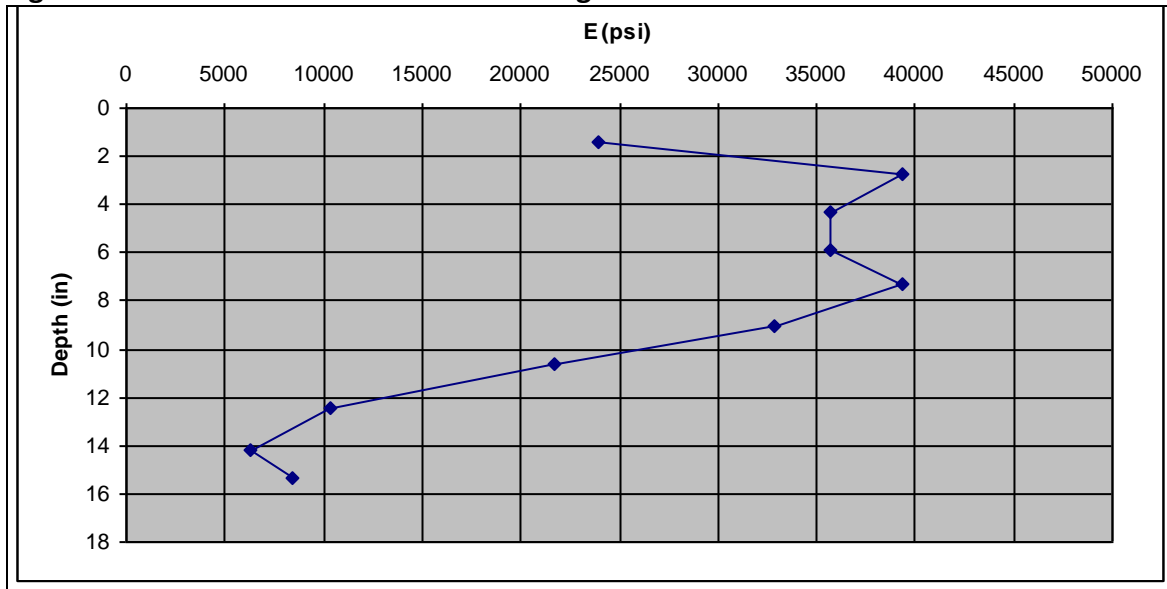
**Figure 8. Modulus Results from DCP Testing at Sta 242+00**

<b>Project:</b>	SH 289 Extension	<b>Date:</b>	3/18/2010
<b>Location:</b>	Sta 242+00	<b>Personnel:</b>	SLH
<b>Zero Point (mm):</b>	420	<b>Hammer Weight (lb):</b>	17.6
<b>Material Classification:</b>		<b>Hammer Blow Factor:</b>	1
<b>Pavement Condition:</b>	LSS	<b>Weather:</b>	Clear

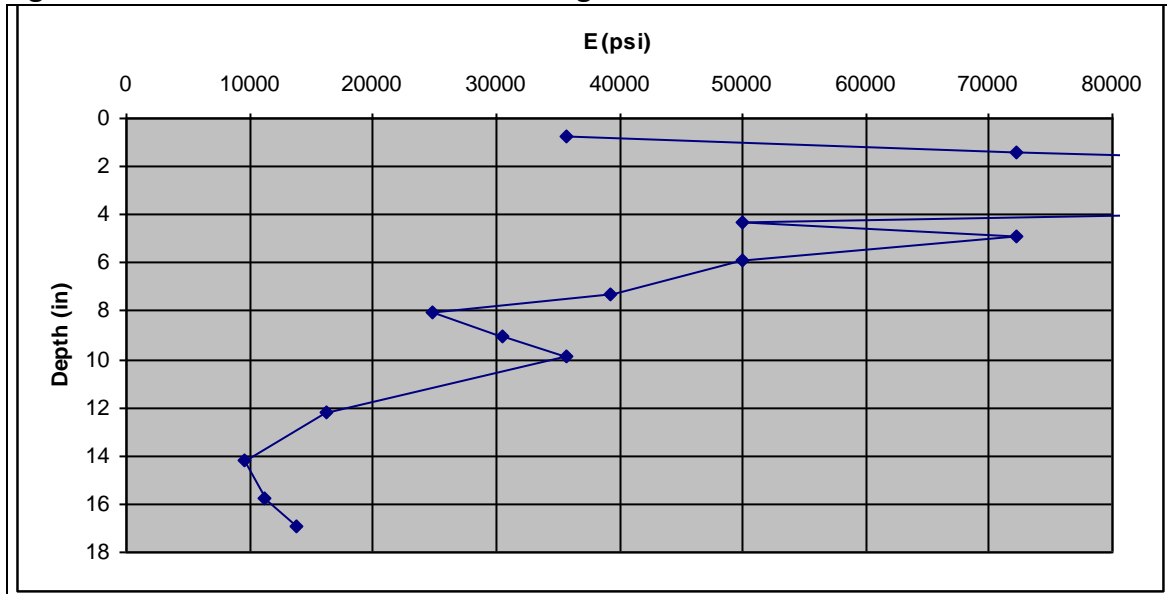
**Figure 9. Modulus Results from DCP Testing at Sta 277+00**

<b>Project:</b>		SH 289 Extension		<b>Date:</b>		3/18/2010	
<b>Location:</b>		Sta 277+00		<b>Personnel:</b>		SLH	
<b>Zero Point (mm):</b>		360		<b>Hammer Weight (lb):</b>		17.6	
<b>Material Classification:</b>				<b>Hammer Blow Factor:</b>		1	
<b>Pavement Condition:</b>		LSS		<b>Weather:</b>		Clear	
<b>Number of Blows</b>	<b>Cumulative Penetration (mm)</b>	<b>Cumulative Penetration (in)</b>	<b>Penetration between Readings (mm)</b>	<b>Penetration /Blow (mm)</b>	<b>DCP Index (mm/blow)</b>	<b>CBR (%)</b>	<b>E (psi)</b>
5	380	0.8	20	4.0	4.0	61.8	35713.2
10	395	1.4	15	1.5	1.5	185.4	72137.8
10	405	1.8	10	1.0	1.0	292.0	96468.4
10	415	2.2	10	1.0	1.0	292.0	96468.4
10	420	2.4	5	0.5	0.5	634.7	158549.0
10	430	2.8	10	1.0	1.0	292.0	96468.4
10	440	3.1	10	1.0	1.0	292.0	96468.4
10	445	3.3	5	0.5	0.5	634.7	158549.0
10	470	4.3	25	2.5	2.5	104.6	50019.8
10	485	4.9	15	1.5	1.5	185.4	72137.8
10	510	5.9	25	2.5	2.5	104.6	50019.8
10	545	7.3	35	3.5	3.5	71.8	39300.4

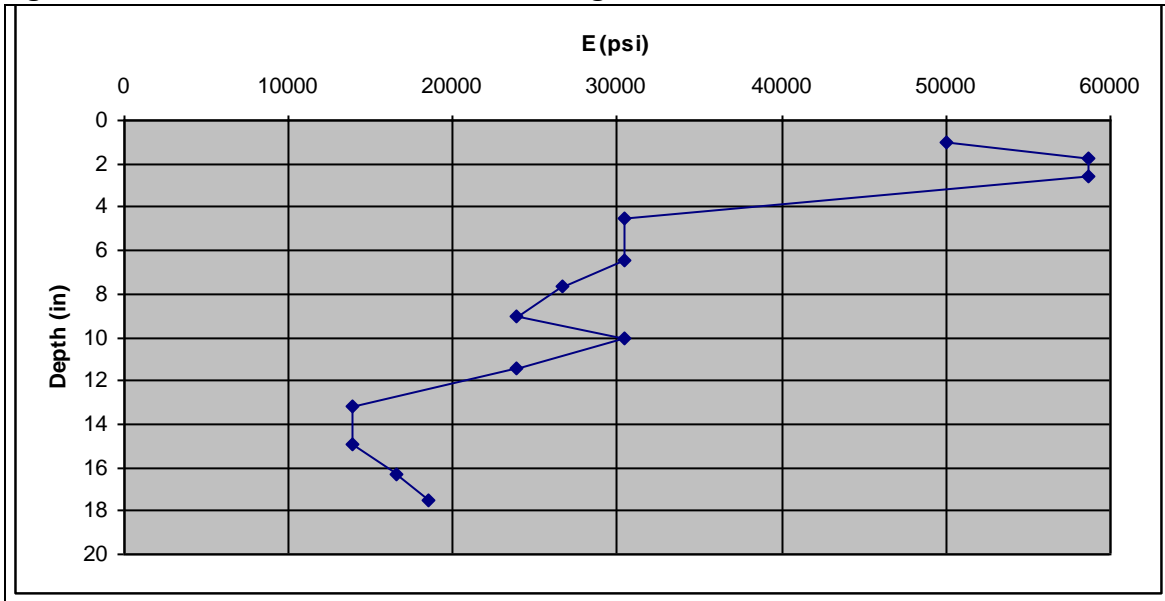
**Figure 10. Modulus Results from DCP Testing at Sta 345+00**

<b>Project:</b>	SH 289 Extension	<b>Date:</b>	3/18/2010
<b>Location:</b>	Sta 345+00	<b>Personnel:</b>	SLH
<b>Zero Point (mm):</b>	365	<b>Hammer Weight (lb):</b>	17.6
<b>Material Classification:</b>		<b>Hammer Blow Factor:</b>	1
<b>Pavement Condition:</b>	LSS	<b>Weather:</b>	Clear
